RESEARCH MEMORANDUM

DITCHING INVESTIGATION OF A $\frac{1}{24}$ - SCALE MODEL

OF THE BOEING B-47 AIRPLANE

By Lloyd J. Fisher and John O. Windham

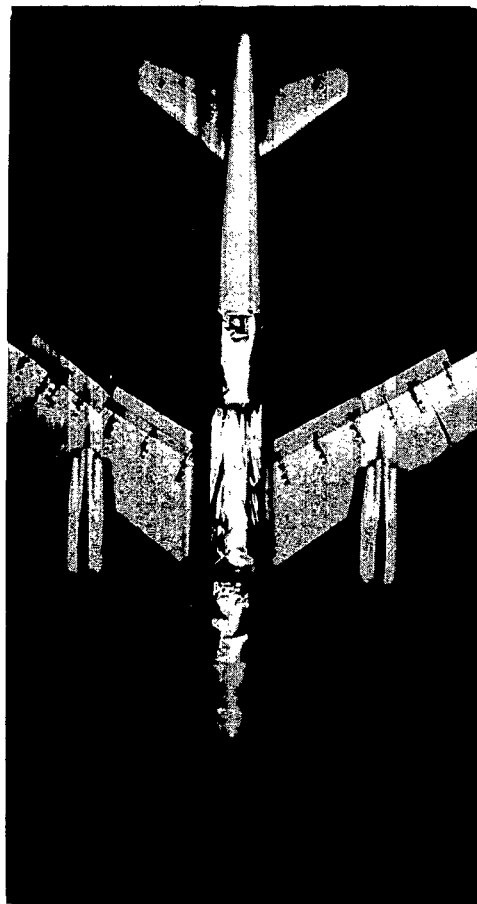
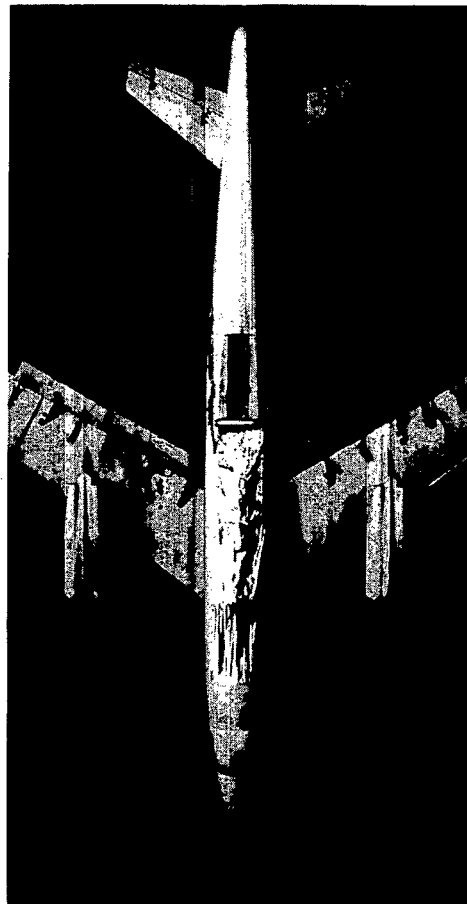
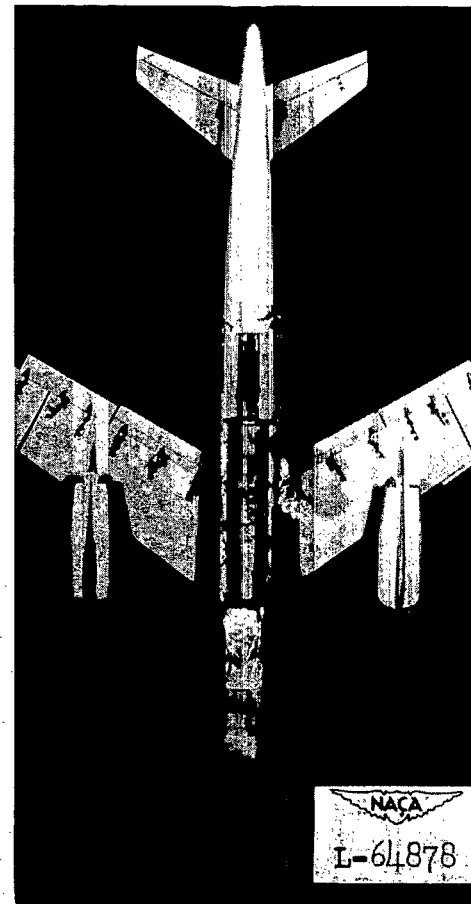
When the model was tested with the bomb-bay and main landing-gear doors replaced with the aluminum covering, some damage always occurred (fig. 5). The model generally made deep but fairly smooth runs with or without the covering and the behavior was about the same at all conditions of damage. The landing runs were between 4 and 6 fuselage lengths with maximum decelerations of about 3g. Damage to the aluminum coverings, even though they were overstrength, indicates that, in a full-scale ditching, the fuselage would be damaged and partially filled with water. Because of the expected inrush of water, crew members should be assigned ditching stations near an exit in the top or forward part of the fuselage and should abandon the airplane quickly.

When the model was tested with full-down flaps, the flaps failed consistently and had no detrimental effect on behavior. The flaps-up position resulted, in general, in slightly higher decelerations and slightly more severe behavior. Much greater damage occurred to the aluminum-covered doors when the flaps were up. These differences in behavior and damage were probably caused by the higher landing speed associated with a flaps-up landing. The results indicate that it would be best for the flaps to be full down in a ditching.

The effect of landing attitude and speed was most apparent in the amount of damage to the aluminum-covered doors. With flaps down, more damage occurred at the 5° attitude than at the 10° and 15° attitudes. Longitudinal decelerations were about the same at all attitudes. Since the most damage with flaps down occurred in the 5° landings, a low attitude should be avoided. The tests indicated very little difference between the 10° and 15° attitude landings; but, because of better flight control, a medium nose-high landing attitude (near 10°) would probably be better in a ditching than a near-stall attitude.

Figure 5.- Damage sustained by aluminum covering replacing the bomb-bay and main landing-gear doors; flaps are full down.

1. The airplane should be ditched at the lowest speed and highest attitude consistent with adequate control; the flaps should be full down.
2. The airplane will probably make a deep but fairly smooth run.
3. The fuselage will probably be damaged and partially filled with water and the nacelles will probably be torn away. Crew members should be assigned ditching stations near an exit in the upper or forward part of the fuselage.
